Preventing failure of gearboxes – Food processing

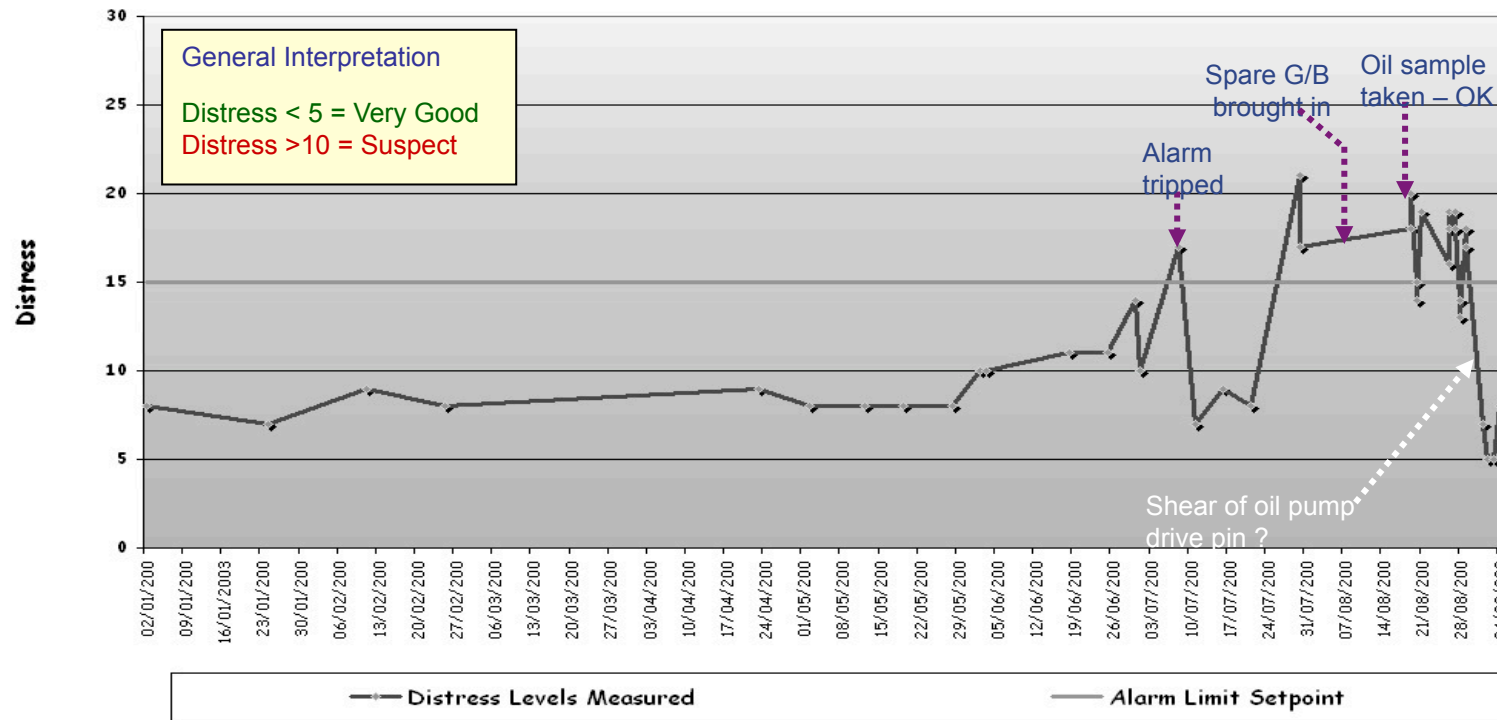
- 5th September Gearbox removed from service & inspection revealed :
 - Oil pump failed (heavily damaged bearing & drive pin sheared).
 - Debris in gearbox but no gearbox damage.
- As a result, gearbox design changed to have external oil pump.
- Vibration Analysis showed no issues throughout.
