Deep Sea Vessel – Recovery Winch

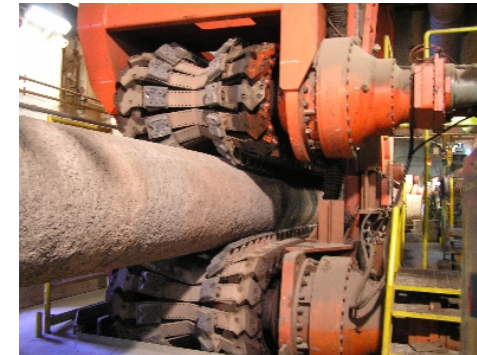
Problem instantly localised.

Closer inspection revealed **starboard lube** channel was **tapped into a blind hole**

Failure of this bearing at deep sea could cost ~£100,000/day out of commission
