Keeping Walkers Running

- Expensive history of unexpected & catastrophic extruder gearbox failures.
- MHC-Memo gives early detection of deterioration in an internal oil-pump.
- Catastrophic failure prevented allowing identification of the root cause.

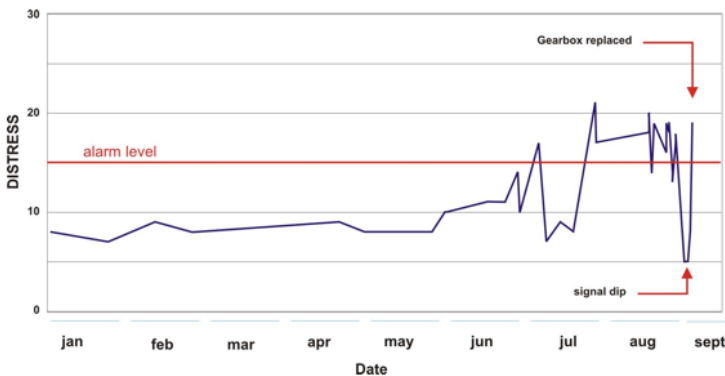
To address this, periodic measurements were initiated using the MHC-Memo instrument when a replacement extruder gearbox was installed in January 2003. The trend of Distress[®] values for the first 9 months of operation of this gearbox is shown in the accompanying plot. From this it can be clearly seen that the Distress[®] reading increased significantly in June 2003 and first tripped the alarm level (set at Distress[®] = 15) in July 2003.

The breakdown of the oil pump, would have rapidly led to extensive internal damage and the complete failure of this gearbox. This suggests that the brief dip in the Distress[®] readings on 2nd September corresponded to the final failure of the oil pump and the subsequent rapid rise corresponded to oil starvation in critical parts (a precursor to what would have been total catastrophic failure).

Although oil analysis showed nothing untoward in the second half of August preparations were made for the gearbox replacement in view of the AE indications. On the weekend of 6th - 7th September the gearbox was replaced (with minimum disruption to production) and it could be immediately seen that the replacement gearbox exhibited normal levels of Distress[®]. When the suspect gearbox was stripped down it revealed that the internal oil pump had failed. Stripping down of this unit revealed significant damage to a bearing race.
